## **Investigation Report for Exceedances of Limit Level of Water Quality Monitoring on 1 June 2023**

<b>Environmental Team for Hung Shui Kui/ Ha Tsuen New Development Area Stage 1 Works – Site Formation and Engineering Infrastructure</b>								
<b>Date</b>	<b>Station</b>	<b>Parameter (Unit)</b>	<b>Depth-averaged Measured Value</b>	<b>Action Level</b>	<b>Limit Level</b>	<b>Exceedance</b>		<b>Project Related (Y/N)</b>
						<b>AL</b>	<b>LL</b>	
01/06	TKW1	Turbidity (NTU)	202.5	27.9	29.2		✓	N
	TKW		190.0	24.2	24.6		✓	N
	SW		33.8	21.4	22.9		✓	N
	TKW1	Suspended Solids (SS) (mg/L)	46.0	16.0	18.4		✓	N
	TKW		36.5	19.8	21.6		✓	N
	SW		15.0	9.7	9.9		✓	N

## **Investigation Report for Exceedances of Limit Level of Water Quality Monitoring on 5 June 2023**

## **Investigation Report for Exceedance of Limit Level of Water Quality Monitoring on 9 June 2023**

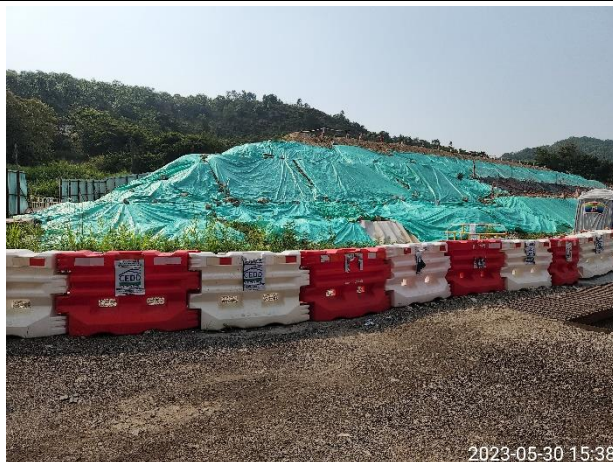
(P1)

Stockpile of dusty materials was covered properly to avoid generation of muddy runoff. No muddy surface runoff was observed during the site inspection.

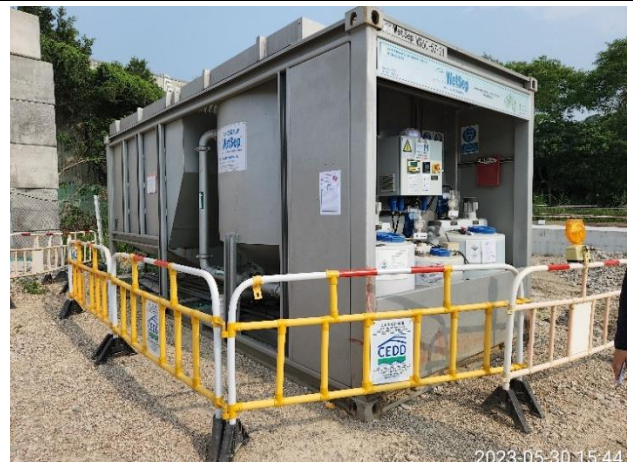
(P2)

Surface runoff and site effluent were collected and diverted to the WetSep for temporary storage and treatment before the water was used for fugitive dust suppression on site.

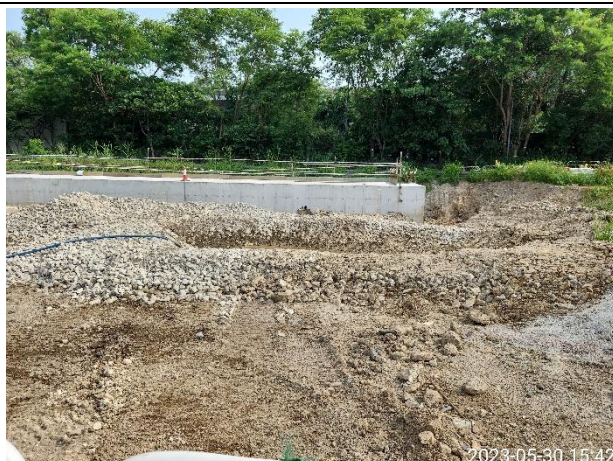
(P3)

Surface runoff was directed to the sump for temporary storage. No muddy surface runoff and no direct discharge of construction effluent was observed.

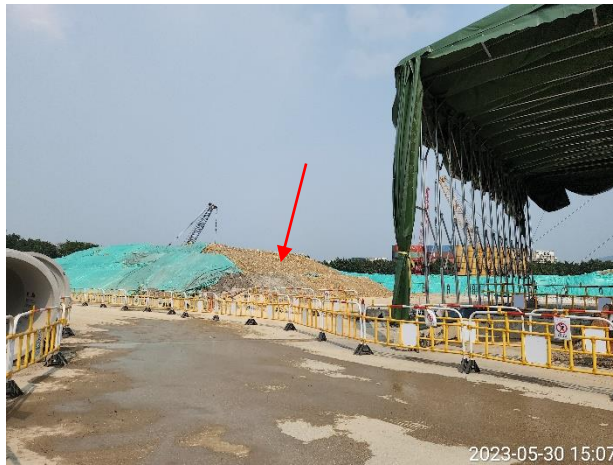
(P4)

Contaminated materials were stocked on site pending for decontamination.

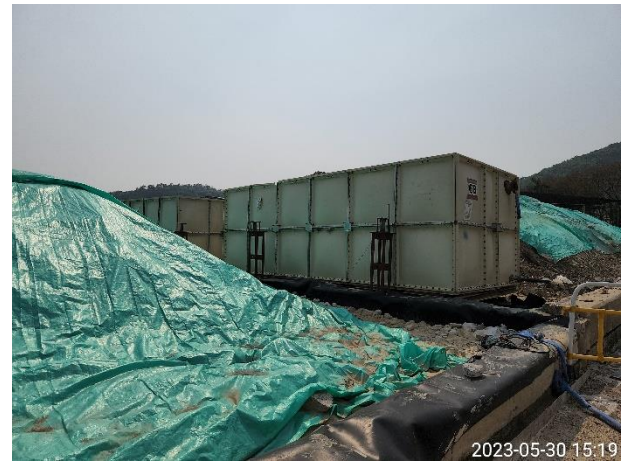
(P5)

Stockpiles within the contaminated soil treatment area were covered by impervious canvases. Leachate collection tanks were also in place.

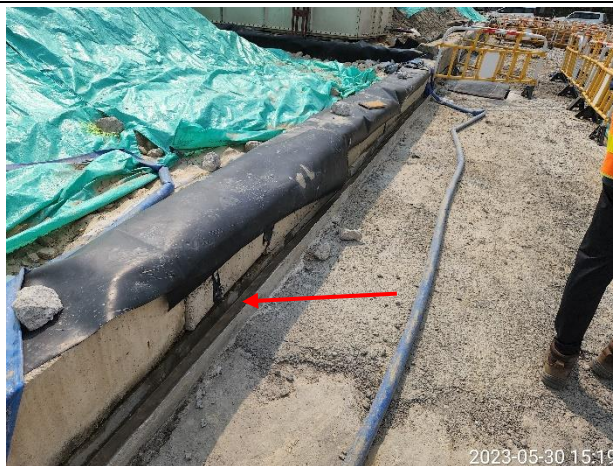
(P6)

Perimeter channels installed outside the contaminated soil treatment area.

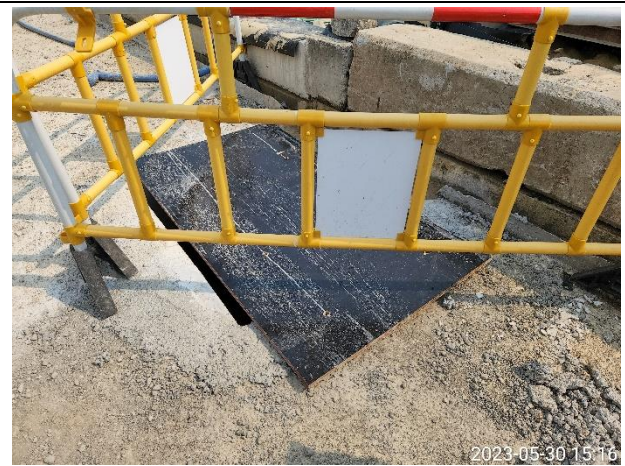
(P7)

Sump pit (under construction) for collection of leachate and surface runoff from stockpiles.

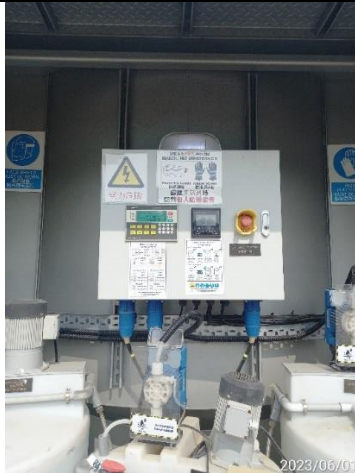
(R1)

WetSep was functioned properly on 1 June 2023

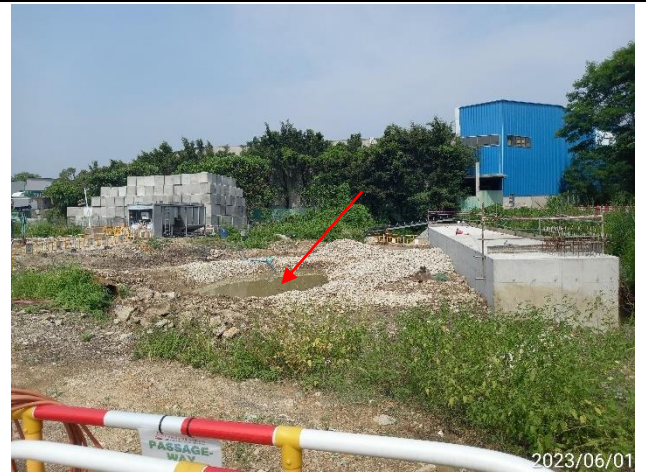
(R2)

Sump formed next to the finished box culvert

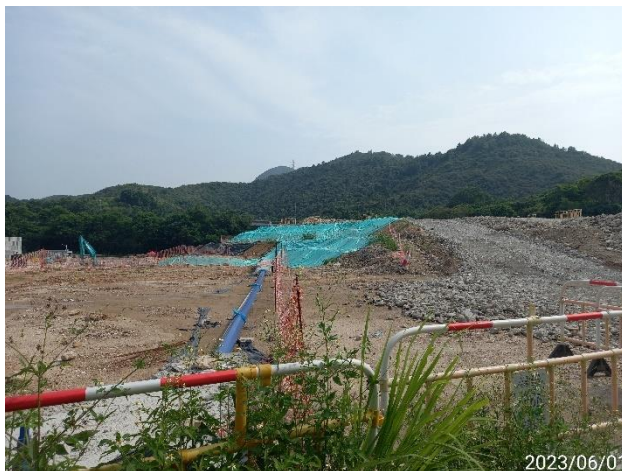
(R3)

No activity was carried out at Site 3-8 (Portion B6). No effluent discharge was observed.

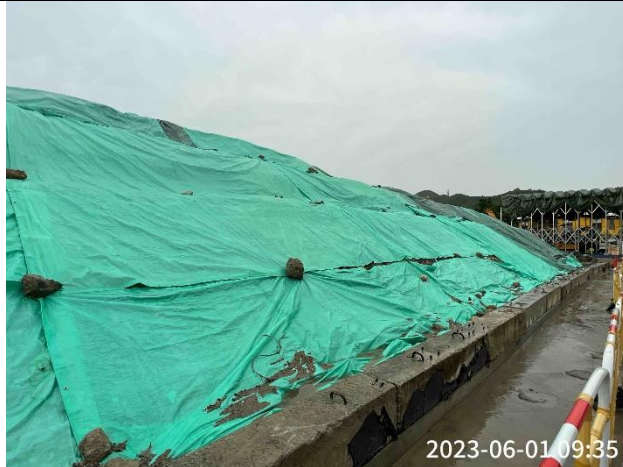
(R5)

Sloping surfaces of stockpiles within the contaminated soil treatment area were covered by impervious canvas.

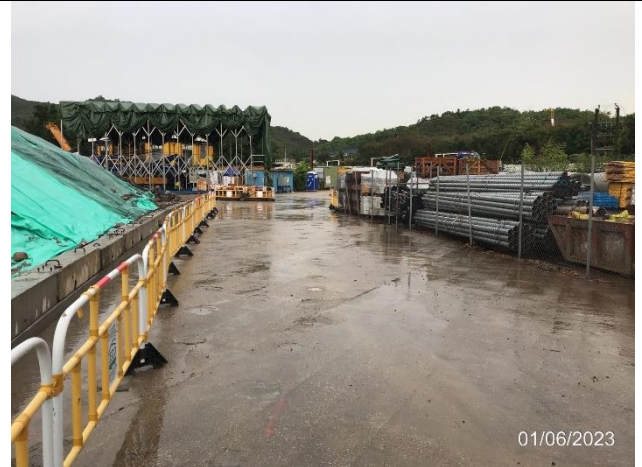
(R6)

No surface runoff or effluent was leaked from the contaminated soil treatment area during the site inspection.

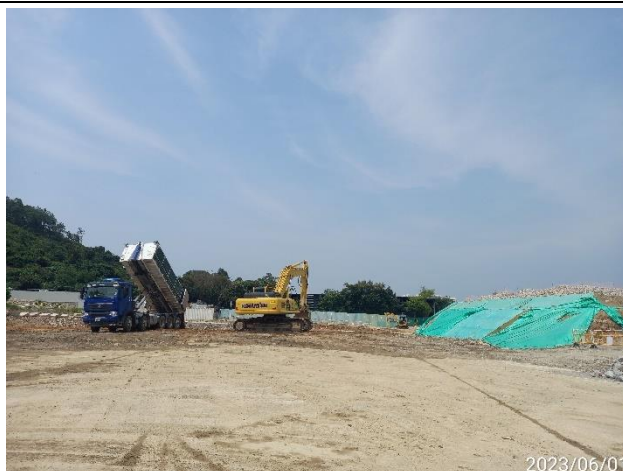
(R7)

No effluent discharge from the site was observed.

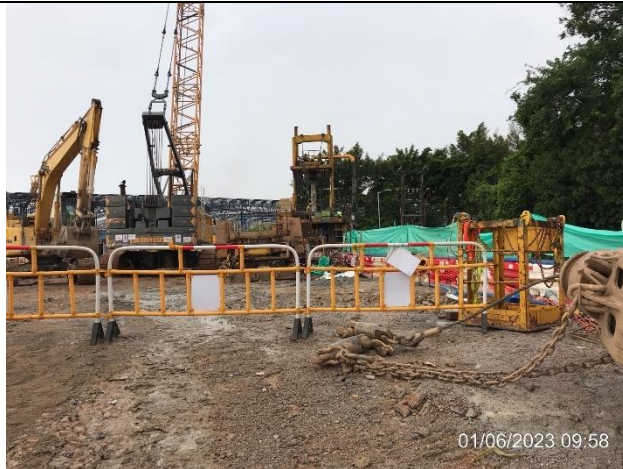
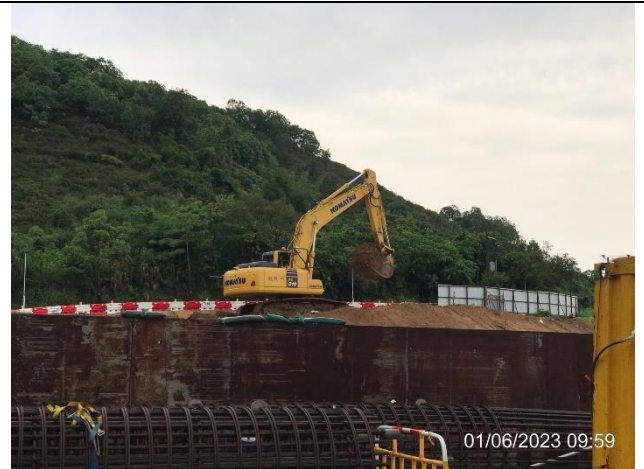
No effluent discharge from the site was observed.

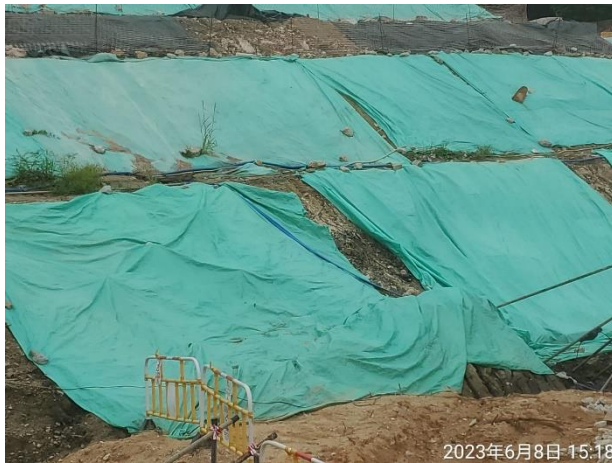
(P1)

Stockpile of dusty materials was covered properly to avoid generation of muddy runoff. No muddy surface runoff was observed during the site inspection.

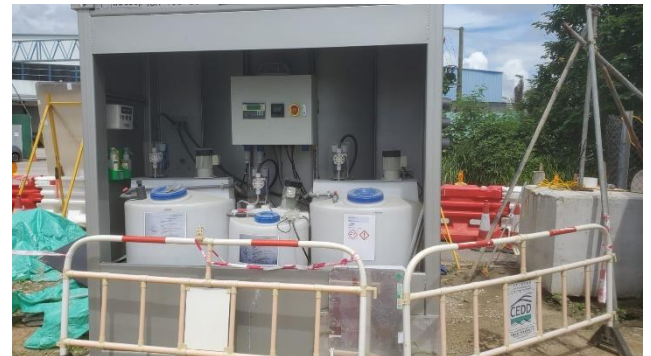
(P2)

Surface runoff and site effluent were collected and diverted to the WetSep for temporary storage and treatment before the water was used for fugitive dust suppression on site.

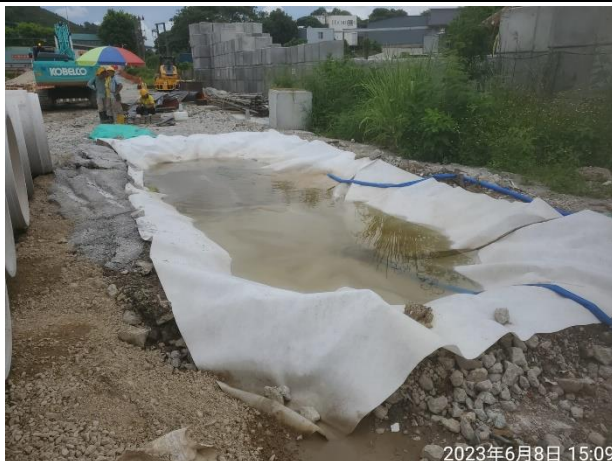
(P3)

Surface runoff was directed to the sump for temporary storage. No muddy surface runoff and no direct discharge of construction effluent was observed.

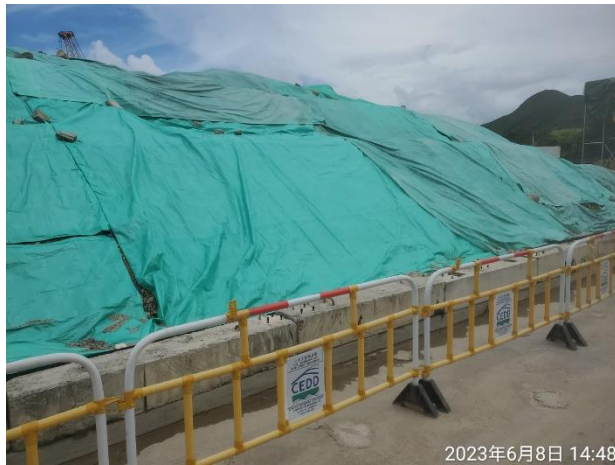
(P4)

Sloping surfaces of stockpiles at the contaminated soil treatment area were covered by impervious canvases to minimize contaminated runoff during rainfall.

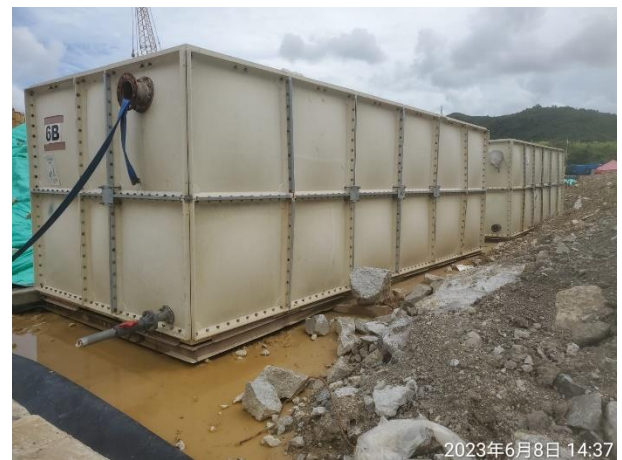
(P5)

Leachate collection tanks were in place at the contaminated soil treatment area.

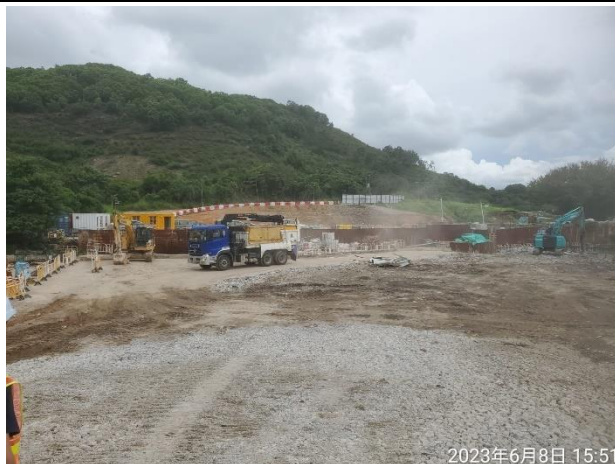
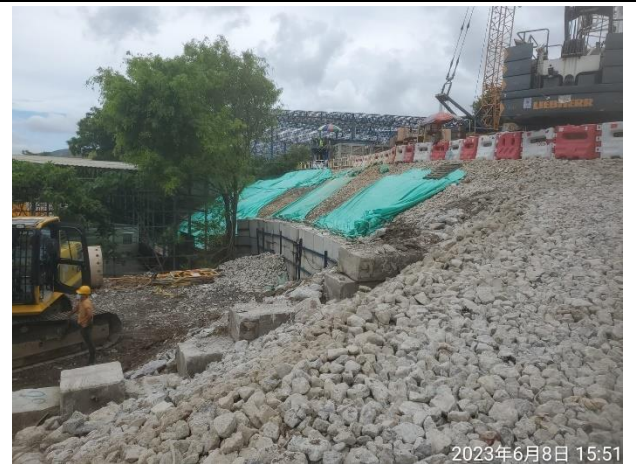
No effluent or surface runoff was observed to discharge from the site.

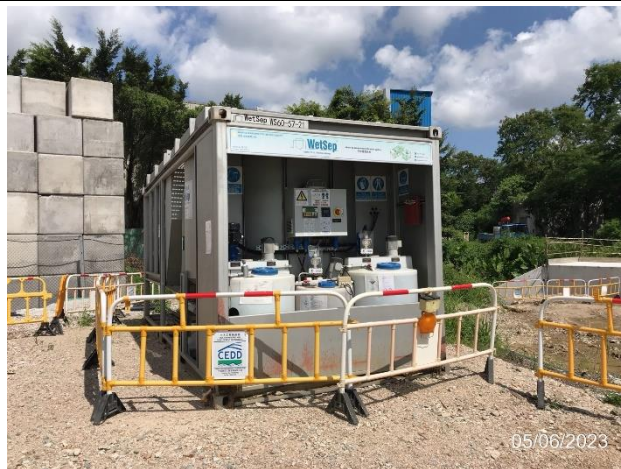
(R1)

The WetSep was functioned properly on 5 June 2023.

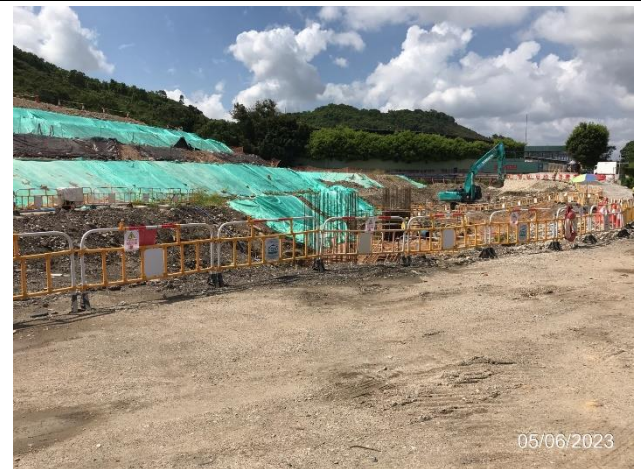
(R2)

No muddy surface runoff was observed on 5 June 2023.

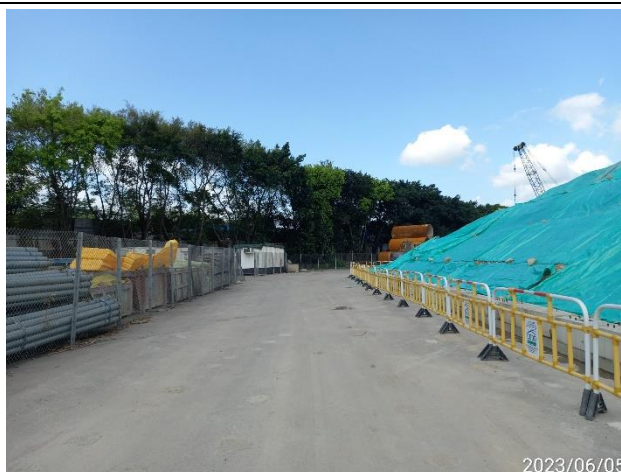
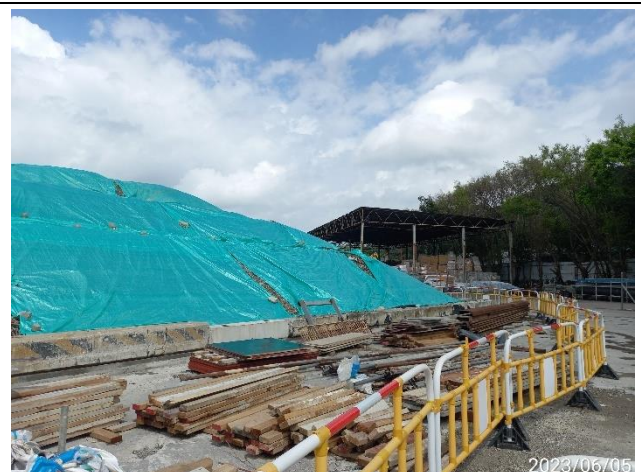
Sloping surfaces of stockpiles at the contaminated soil treatment area were covered by impervious canvases to minimise contaminated runoff during rainfall. No surface runoff or effluent was leaked from the contaminated soil treatment area during the site inspection.

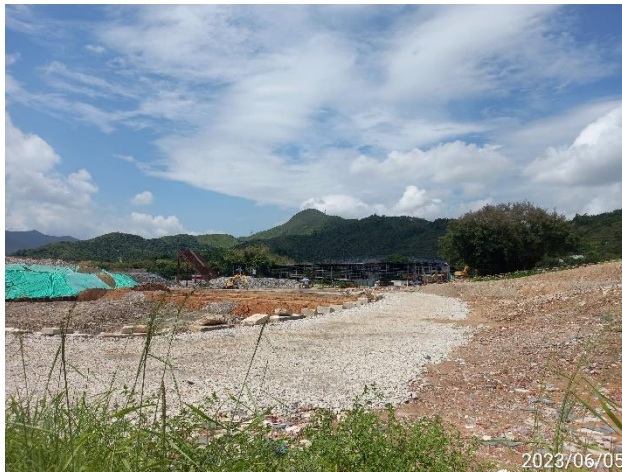
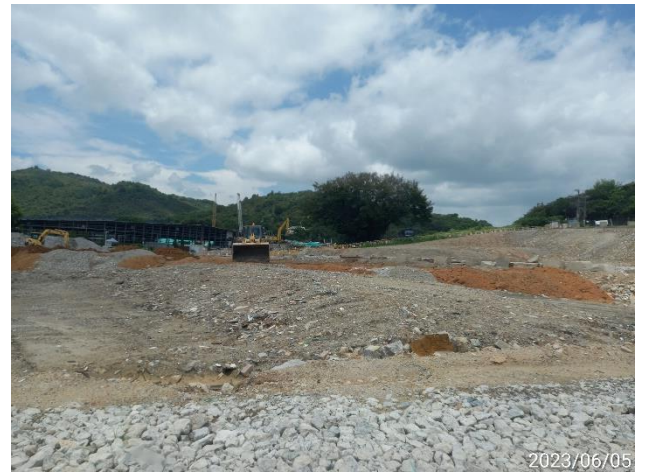
No effluent or surface runoff was observed on site.

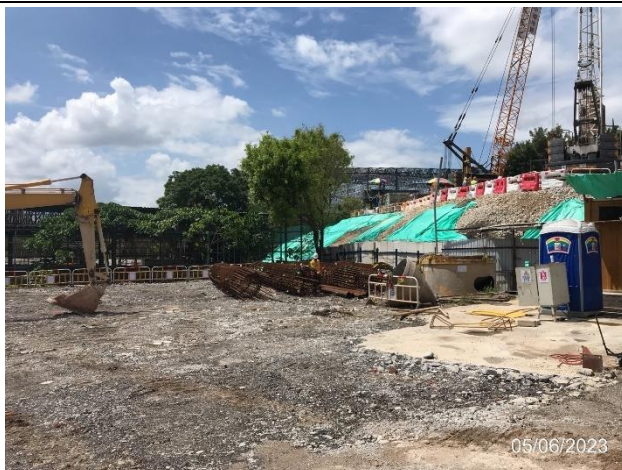
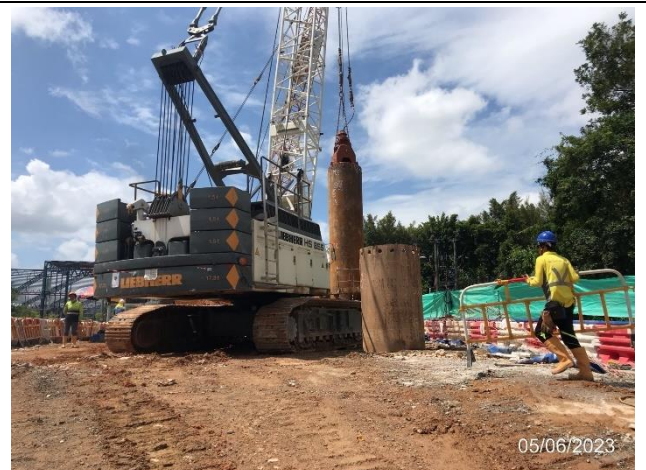
No effluent or surface runoff was observed on site.

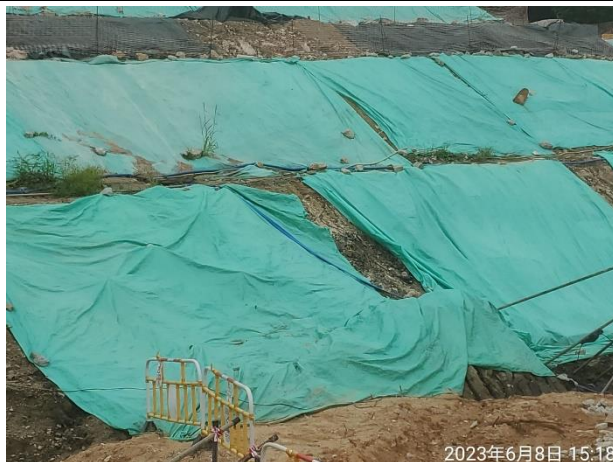
(P1)

Stockpile of dusty materials was covered properly to avoid generation of muddy runoff. No muddy surface runoff was observed during the site inspection.

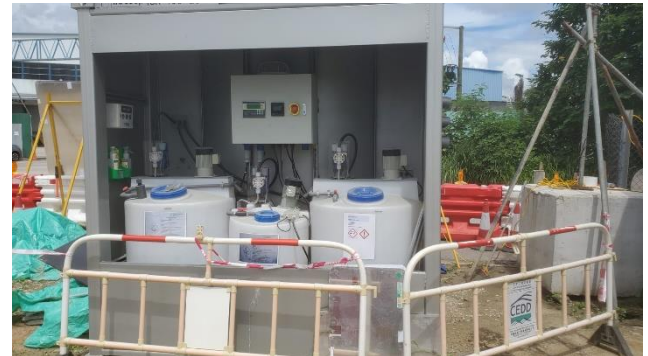
(P2)

Surface runoff and site effluent were collected and diverted to the WetSep for temporary storage and treatment before the water was used for fugitive dust suppression on site.

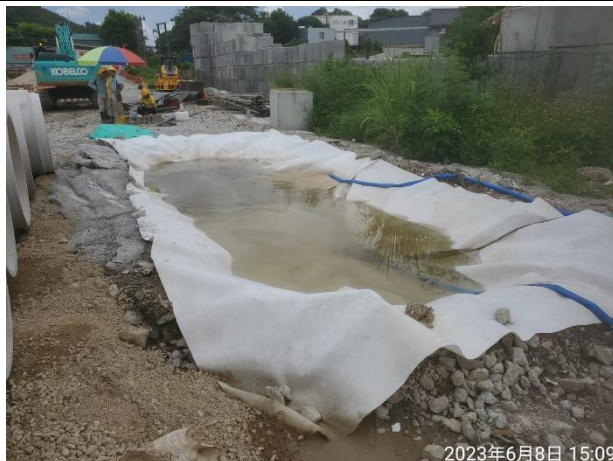
(P3)

Surface runoff was directed to the sump for temporary storage. No muddy surface runoff and no direct discharge of construction effluent was observed.

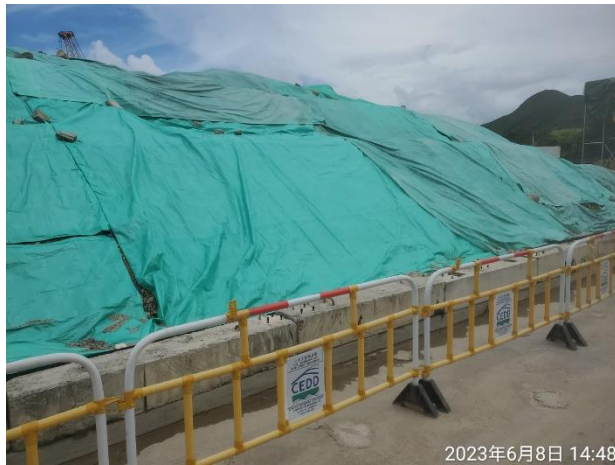
(P4)

Sloping surfaces of stockpiles at the contaminated soil treatment area were covered by the impervious canvases to minimize contaminated runoff during rainfall.

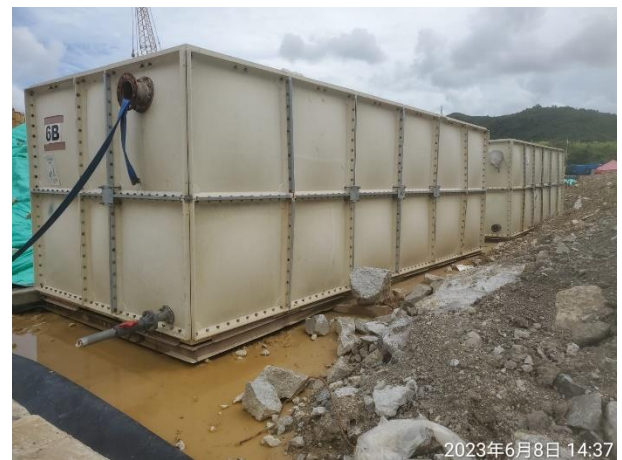
(P5)

Leachate collection tanks were in place at the contaminated soil treatment area.

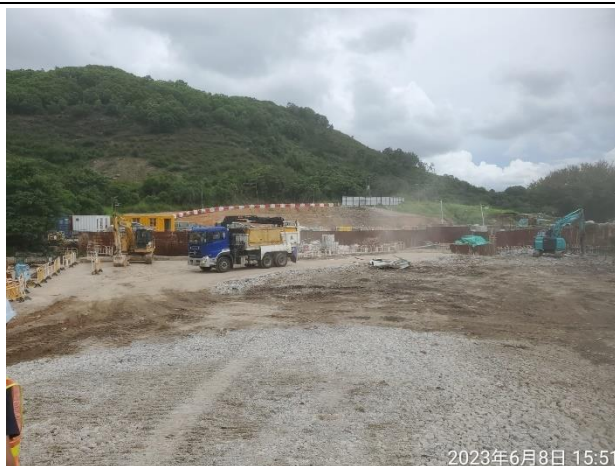
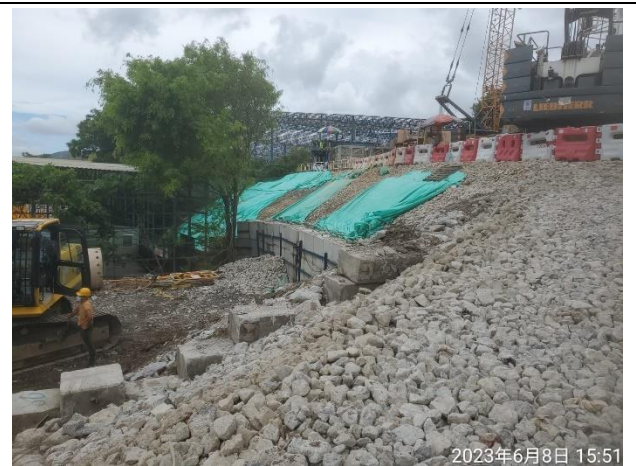
No effluent or surface runoff was observed to discharge from the site.

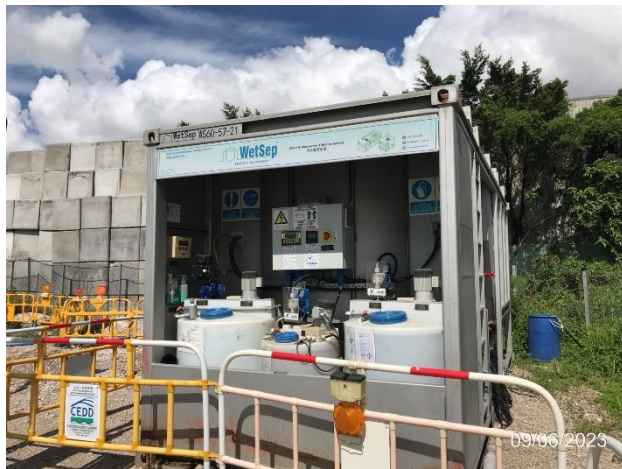
(R1)

The WetSep was functioned properly on 9 June 2023.

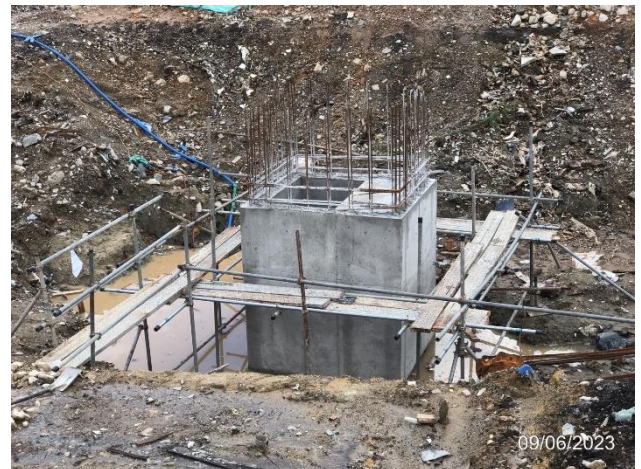
(R2)

Rain water deposited around the manhole was diverted to the sump for temporary storage prior to treatment by the WetSep on site.

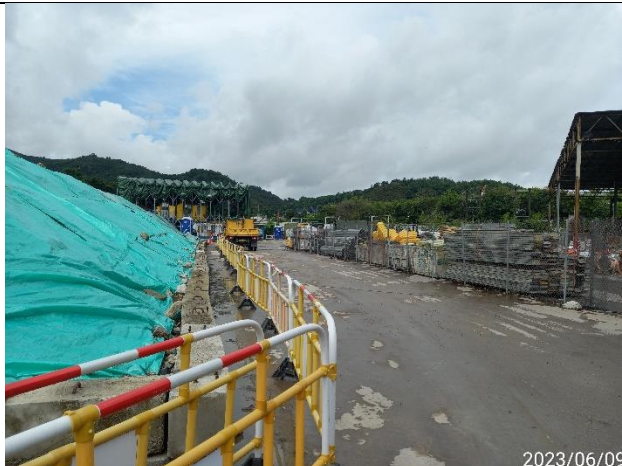
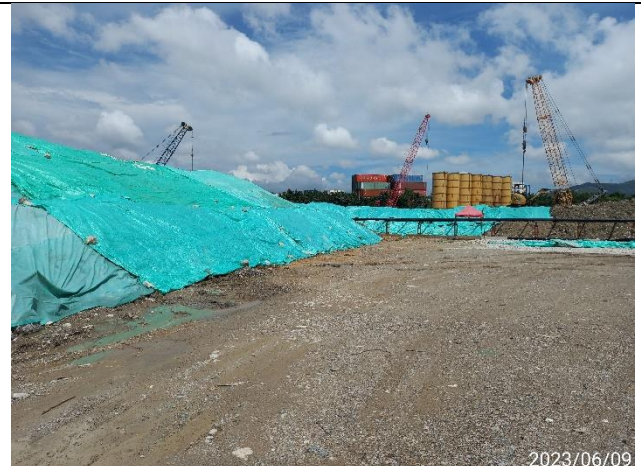
Sloping surfaces of stockpiles at the contaminated soil treatment area were covered by impervious canvases to minimise contaminated runoff during rainfall. No surface runoff or effluent was leaked from the contaminated soil treatment area during the site inspection.

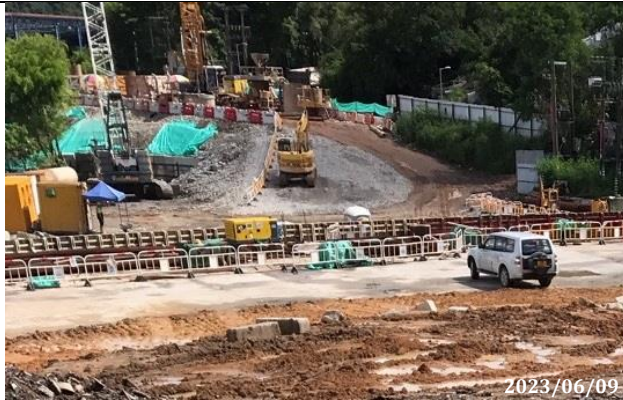
(R4)

No effluent or surface runoff was observed to discharge from the site.
