**Investigation Report for Exceedances of Limit Levels of Water Quality Monitoring on 14 November 2023**

<b>Environmental Team for Hung Shui Kiu/ Ha Tsuen New Development Area Stage 1 Works – Site Formation and Engineering Infrastructure</b>								
Date	Station	Parameter (Unit)	Depth-averaged Measured Value	Action Level	Limit Level	Exceedance		Project Related (Y/N)
						AL	LL	
14/11	TKW1	Suspended Solids (SS) (mg/L)	8.0	7.1	7.8		✓	N
	TKW		12.0	7.0	7.1		✓	N

**Investigation Report for Exceedances of Limit Levels of Water Quality Monitoring on 18 November 2023**

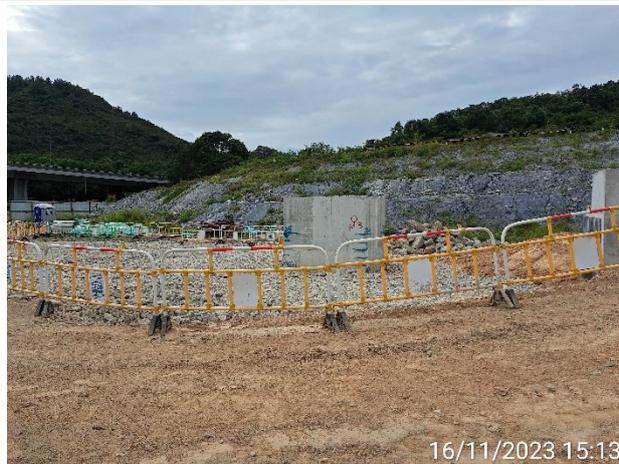
(P1)

Stockpile of dusty materials was covered properly to avoid generation of muddy runoff. No muddy surface runoff was observed during the site inspection.

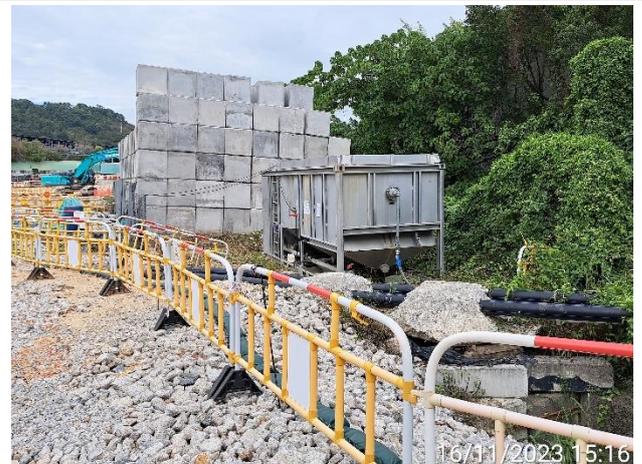
(P2)

Surface runoff and site effluent were collected and diverted to the WetSep for temporary storage and treatment before the water was used for fugitive dust suppression on site or discharged at designated location under the requirement of effluent discharge licence.

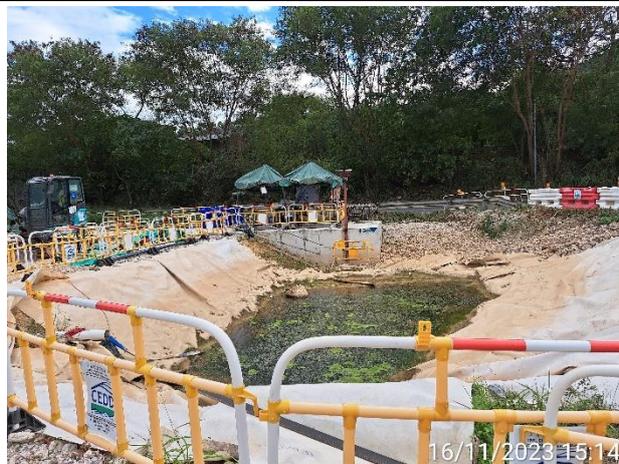
(P3)

Surface runoff was directed to the sump/ detention pond for temporary storage. No muddy surface runoff and no direct discharge of construction effluent was observed.

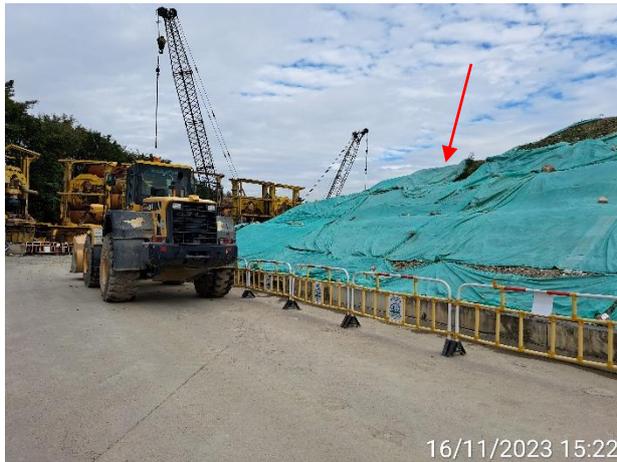
(P4)

Contaminated materials were stocked on site.

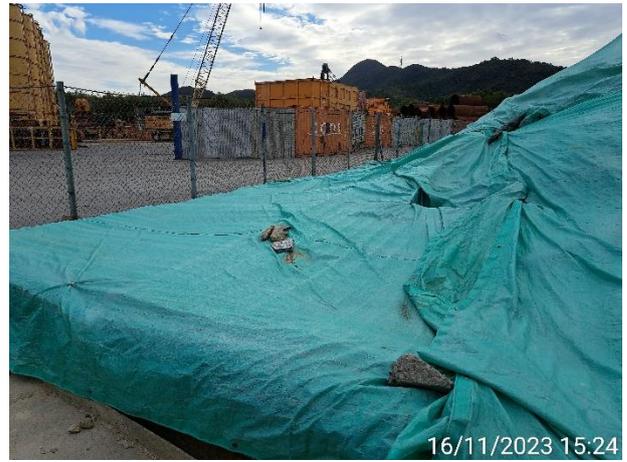
(P5)

Stockpiles within the contaminated soil treatment area were covered by impervious canvases.

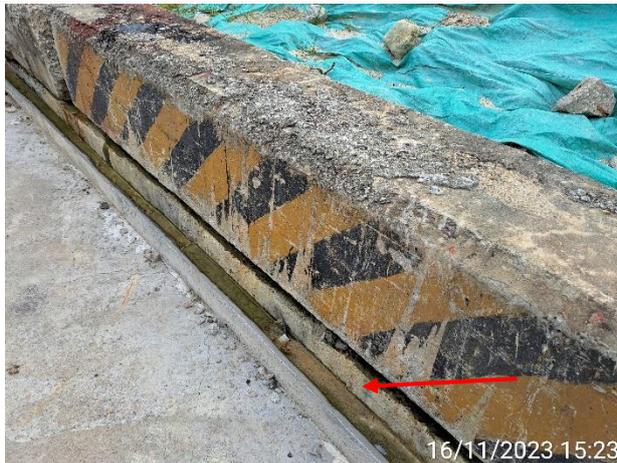
(P6)

Perimeter channels were installed outside the contaminated soil treatment area.

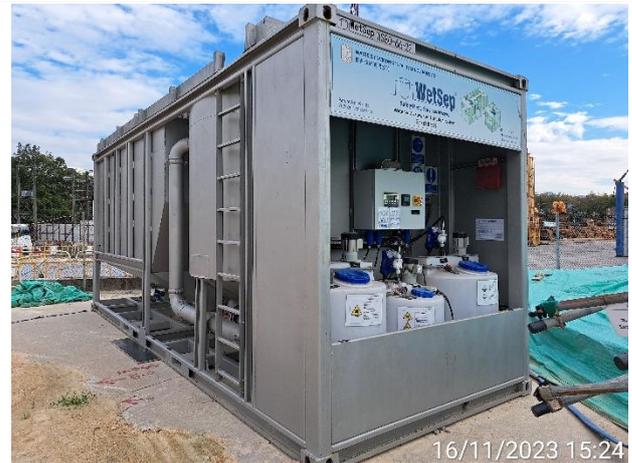
(P7)

A WetSep was provided on site to treat and store construction effluent from Site 3-6, Site 3-7, and Contaminated Soil Treatment Area. No off-site effluent discharge was recorded in November 2023.

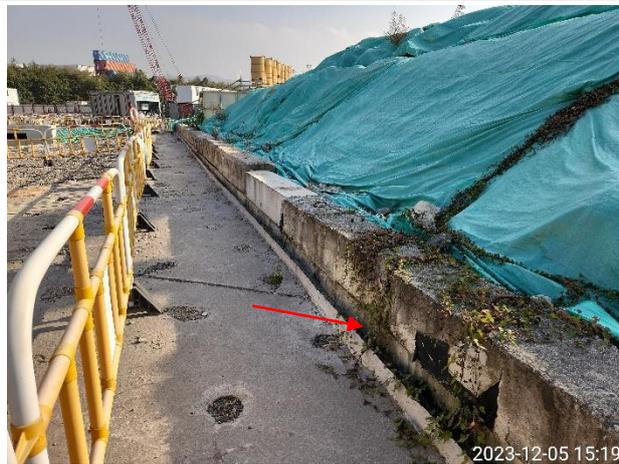
(P8)

Contaminated materials were covered by canvases and stocked on site. Perimeter channels were installed outside the contaminated soil treatment area.

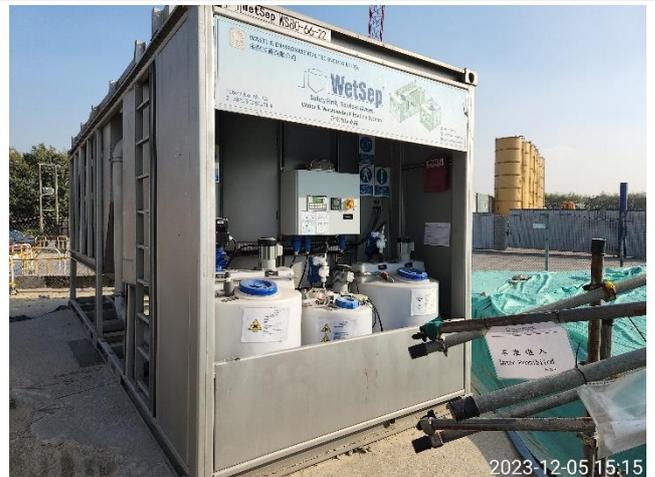
(P9)

A WetSep was provided on site to treat and store construction effluent from Site 3-6, Site 3-7 and Contaminated Soil Treatment Area. No off-site effluent discharge was recorded in November 2023.

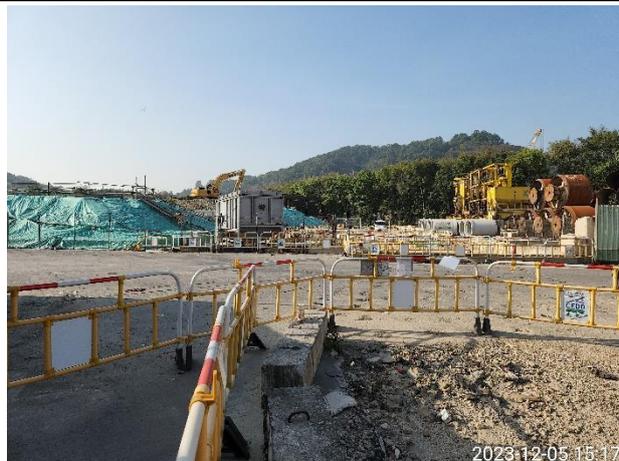
(P10)

An effluent discharge license for Site 3-6, Site 3-7 and Contaminated Soil Treatment Area has been acquired in November 2023. A channel constructed for off-site discharge of treated effluent was dry and no wastewater was observed.

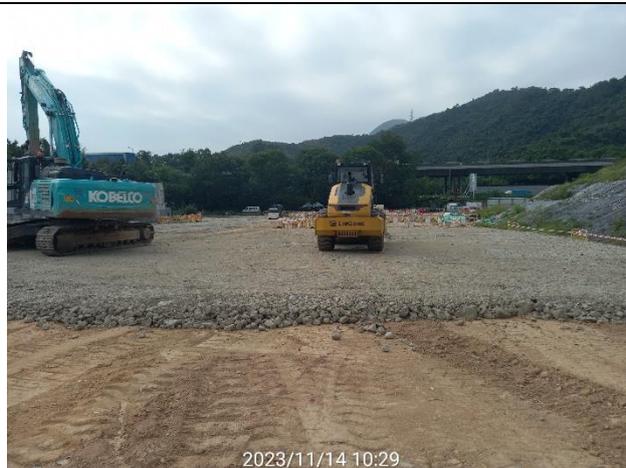
(R1)

The road roller was provided to avoid generation of muddy runoff.

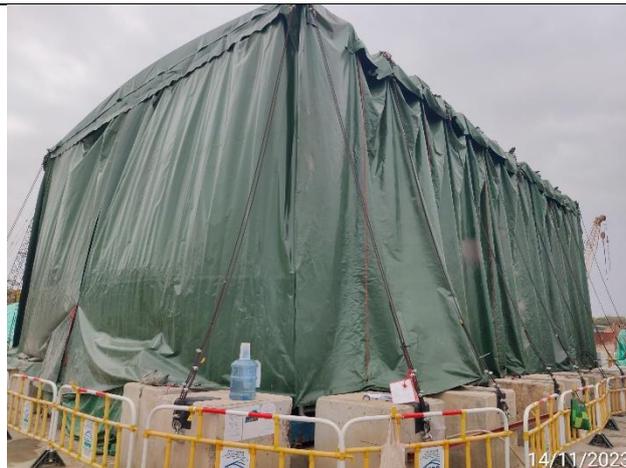
(R2)

The contaminated soil treatment area were covered by impervious canvas. No surface runoff or effluent was leaked from the contaminated soil treatment area during the site inspection.

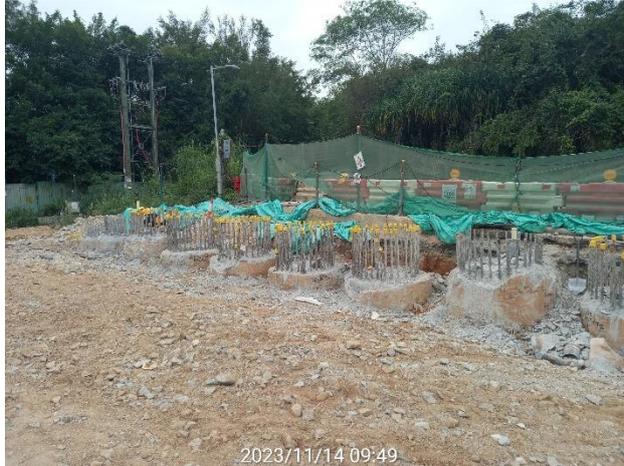
(R3)

No effluent discharge from the site was observed.

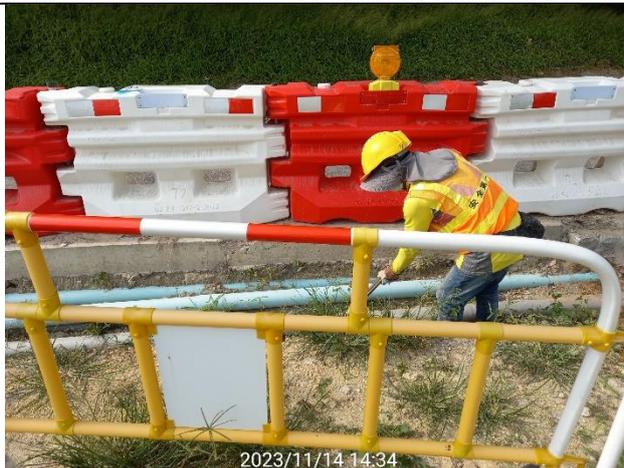
(R4)

No effluent discharge from the site was observed.

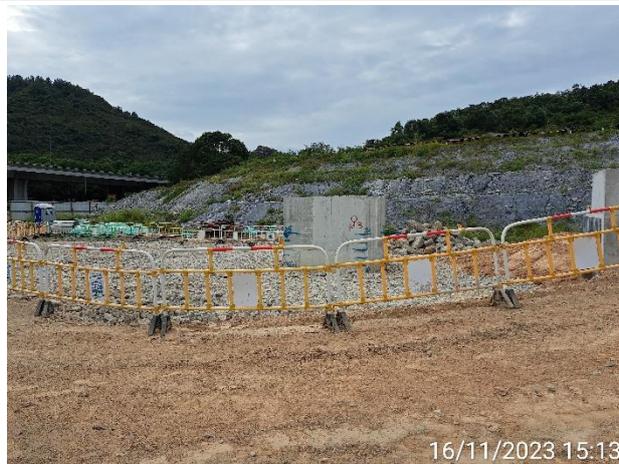
(P1)

Stockpile of dusty materials was covered properly to avoid generation of muddy runoff. No muddy surface runoff was observed during the site inspection.

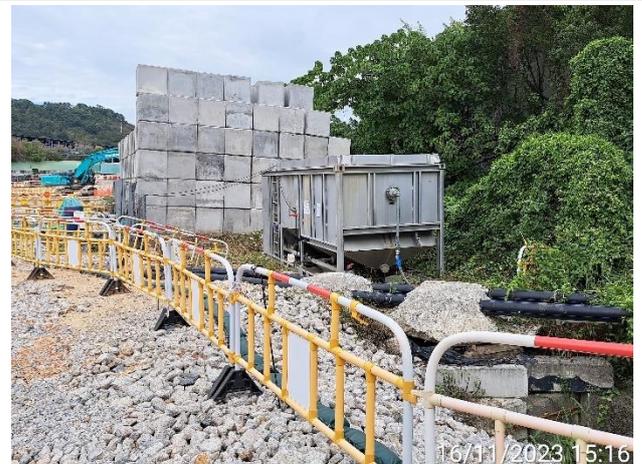
(P2)

Surface runoff and site effluent were collected and diverted to the WetSep for temporary storage and treatment before the water was used for fugitive dust suppression on site or discharged at designated location under the requirement of effluent discharge licence.

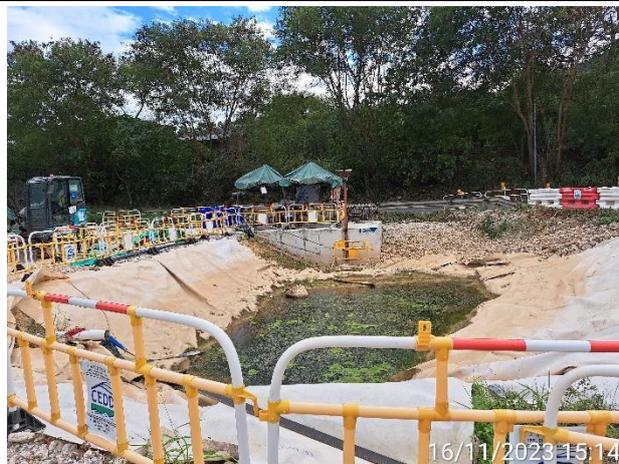
(P3)

Surface runoff was directed to the sump/ detention pond for temporary storage. No muddy surface runoff and no direct discharge of construction effluent was observed.

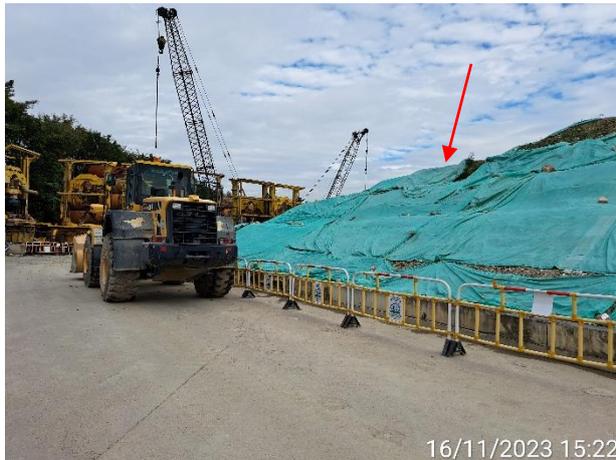
(P4)

Contaminated materials were stocked on site pending for decontamination.

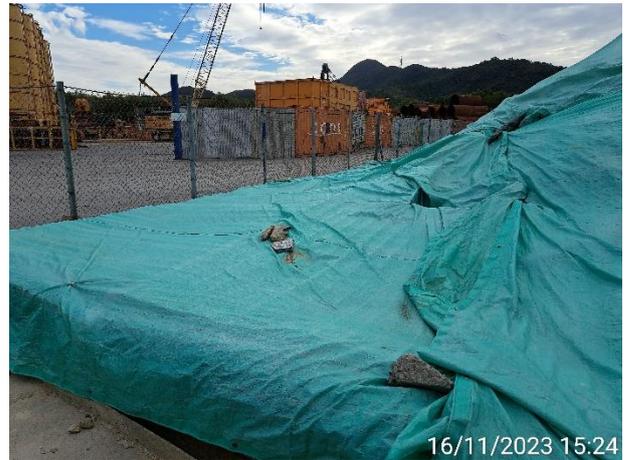
(P5)

Stockpiles within the contaminated soil treatment area were covered by impervious canvases.

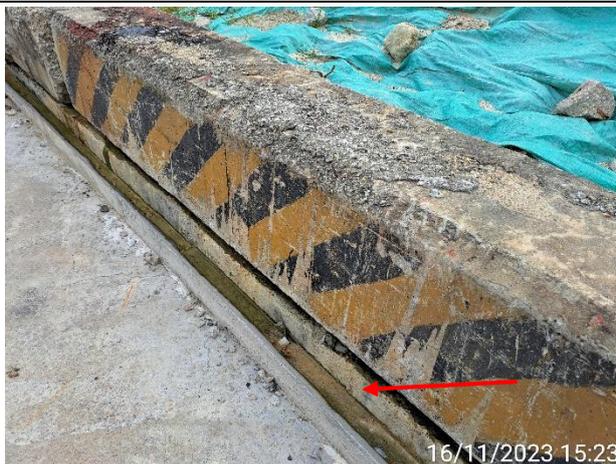
(P6)

Perimeter channels were installed outside the contaminated soil treatment area.

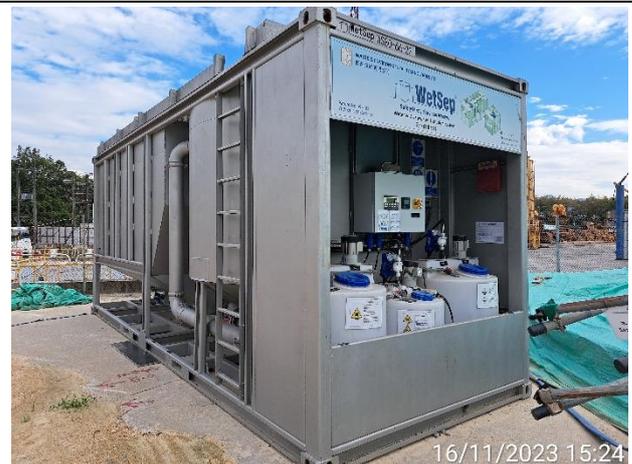
(P7)

A WetSep was provided on site to treat and store construction effluent from Site 3-6, Site 3-7, and Contaminated Soil Treatment Area. No off-site effluent discharge was recorded in November 2023.

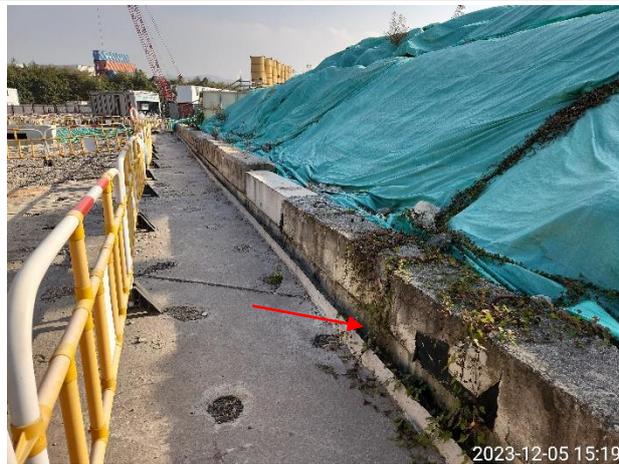
(P8)

Contaminated materials were covered by canvases and stocked on site. Perimeter channels were installed outside the contaminated soil treatment area.

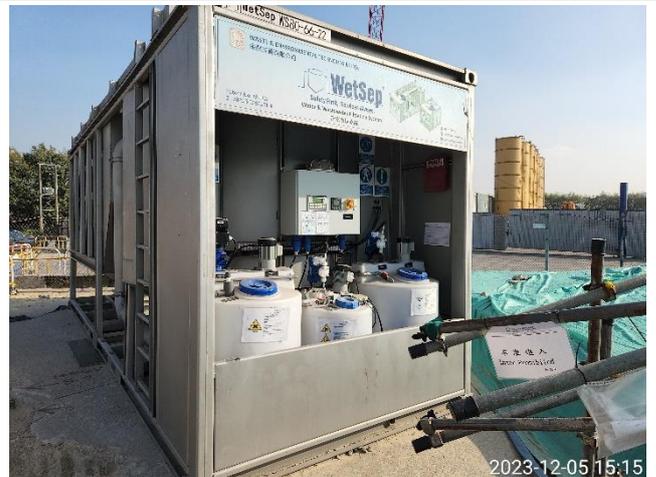
(P9)

A WetSep was provided on site to treat and store construction effluent from Site 3-6, Site 3-7 and Contaminated Soil Treatment Area. No off-site effluent discharge was recorded in November 2023.

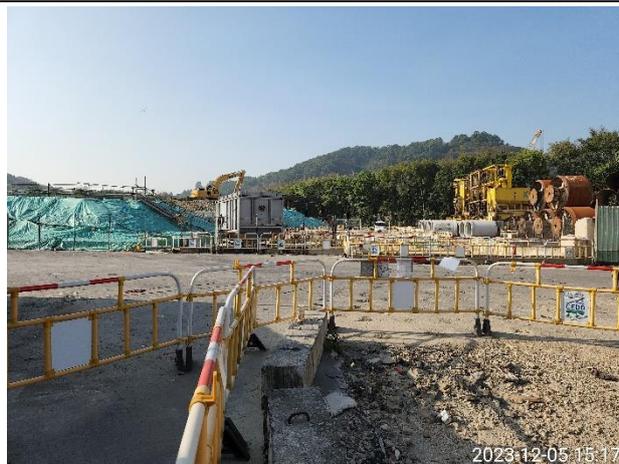
(P10)

An effluent discharge license for Site 3-6, Site 3-7 and Contaminated Soil Treatment Area has been acquired in November 2023. A channel constructed for off-site discharge of treated effluent was dry and no wastewater was observed.

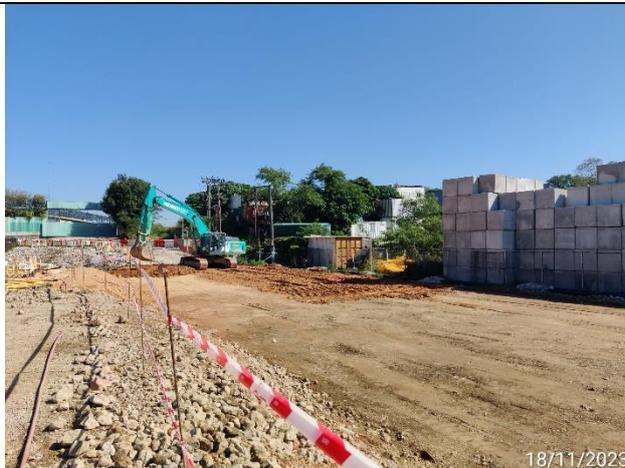
(R1)

No effluent discharge from the site was observed.

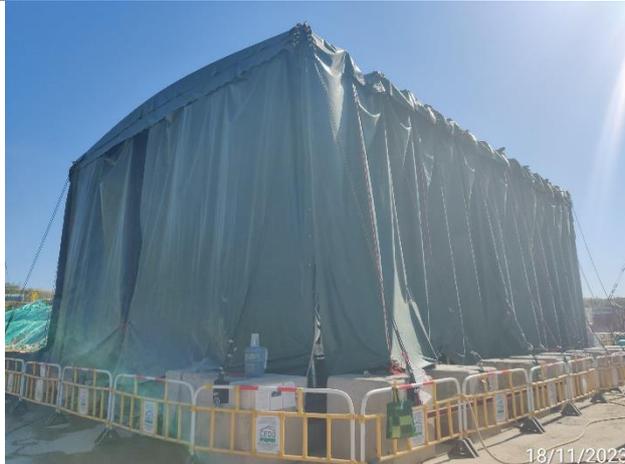
(R2)

The contaminated soil treatment area were covered by impervious canvas. No surface runoff or effluent was leaked from the contaminated soil treatment area during the site inspection.

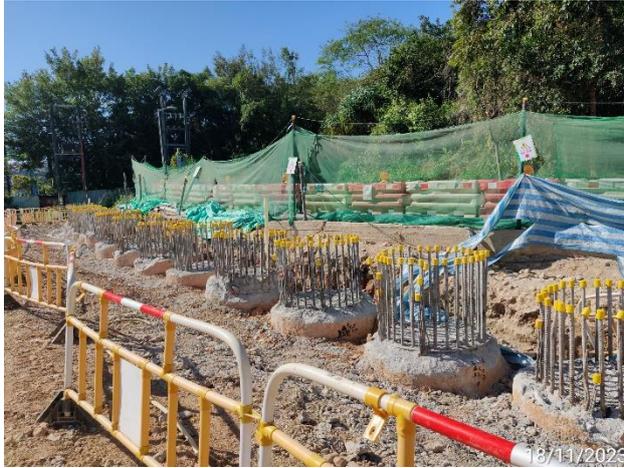
(R3)

No effluent discharge from the site was observed.

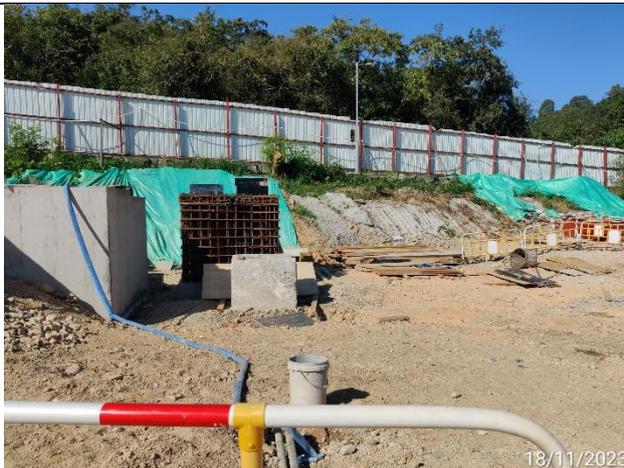
(R4)

No effluent discharge from the site was observed.
