Service Contract No. WD/02/2021

Environmental Team for Hung Shui Kiu/Ha Tsuen New Development Area Stage 1 – Site Formation and Engineering Infrastructure

Monthly EM&A Report (May 2023)

(Environmental Permit No. EP-528/2017)

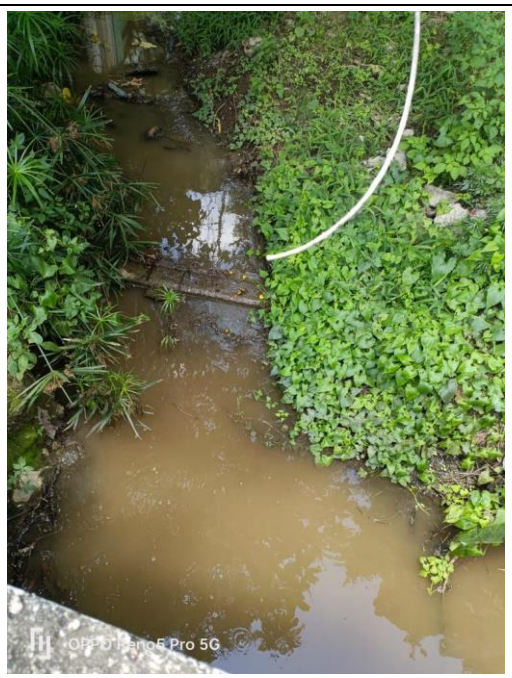
Site Observation Photos around Water Quality Monitoring Stations taken on 4 May 2023

(P4) Water Quality Monitoring Station: TKW	(P5) Water Quality Monitoring Station: TKW1
